## **CASE STUDY TO EVALUATE EFFECTS OF BUILDING CODE VIOLATIONS ON THE OUTCOME OF A FATALITY FIRE**

Noel Putaansuu, CFI, Michael M. Fitz, P.E., C.F.E.I., C.F.P.S.

MDE Inc.  
700 S Industrial Way  
Seattle, WA 98108  
e-mail: NoelP@mde.com

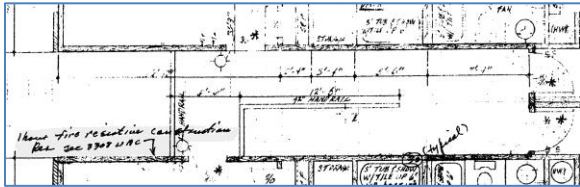
1. Within the main entry corridor “1 hr fire resistive construction Section 3308 UBC” written in for the 1<sup>st</sup> floor and 2<sup>nd</sup> floor plans (Figure 4).
2. Within the arc of each main entry door an “\*” was draw. Below the diagram was written “\* 1 hour rated door assemblies” (Figure 5).

Figure 4: hand written note in corridor “ 1 hour fire resistive construction Rec. Section 3308 UBC”

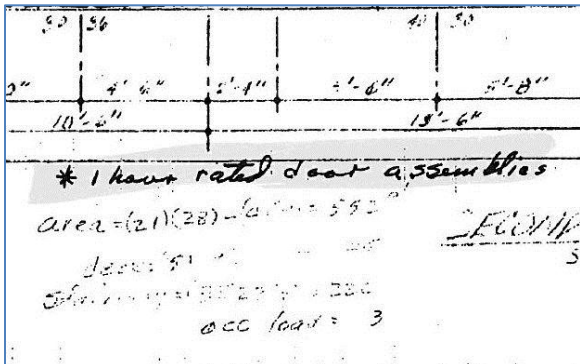
Figure 5: hand written note in margin with asterisk. “ 1 hour rated door assemblies” Each door had an asterisk within the door arc.

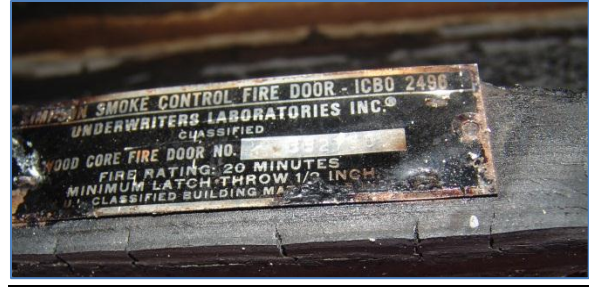
During the code review, it was determined that one hour doors and self-closing hardware were required. An examination of the remaining doors in the subject and exemplar building resulted in the following (Figure 6):

- Smoke control fire door
- UL classified
- Wood core fire door
- Fire Rating 20 minutes
- No evidence of door closure hardware or attachment points.

Figure 6: Door plate, fire rating 20 minute particleboard core

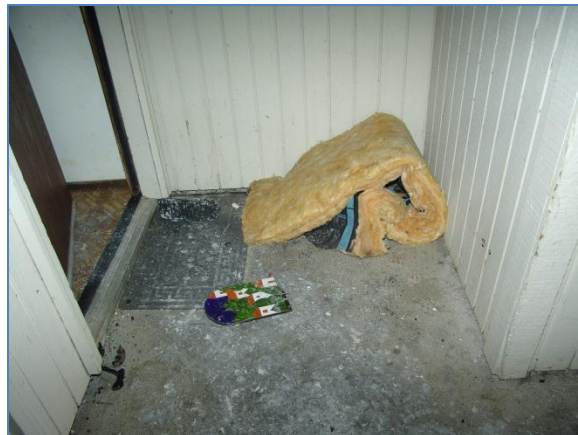
Based on the very rapid spread noted by the initial 911 caller and the witness from unit 1, the initial stages of a “hidden” ignition were evaluated (Figure 7). The location of the initial fire was behind the stairway and was not visible from the street or parking lot. This allowed the fire to develop and spread up the siding to the second story landing before being noticed. There were no lights to show any developing smoke.

Figure 7: Estimated size of pile of bagged clothes placed in front of door #3 in an exemplar building.

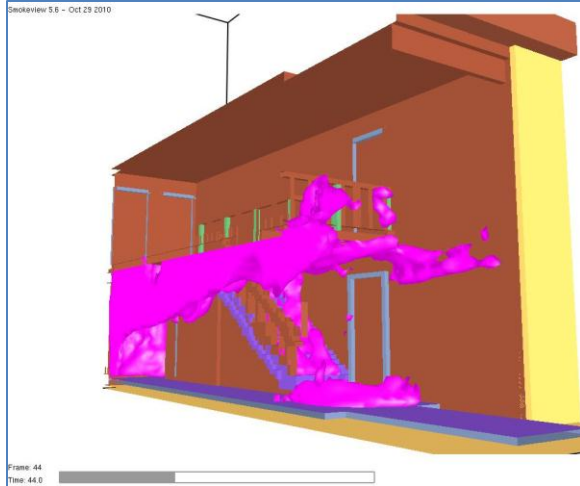
The modeling indicated that the combustible material that lined the covered exit passage quickly provided an untenable environment within the covered corridor (Figure 8).

Figure 8: FDS 4.07 Corridor model with T1-11 walls and ceiling and carpeted flooring

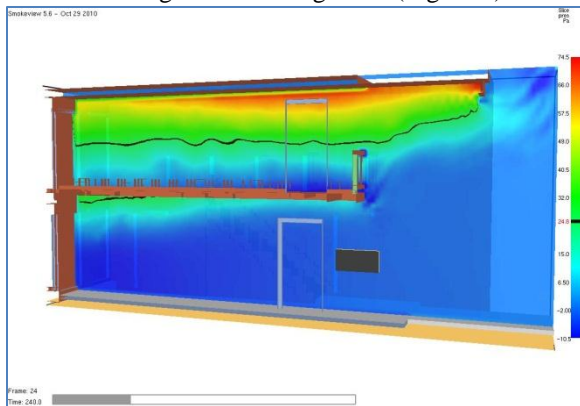
The modeling indicated that wind and draft pressure levels at the second story doors #6 & #7 were low enough that an average door closure hardware with 5 pounds of force would have been able to overcome the wind and fire plume pressures during the initial and middle stages of the fire growth (Figure 9).

Figure 9: FDS 4.07 Model with Pressure slice through doors 2 and 6.

During the post flashover stages, the door closures would probably not fully latch the door closed, however; it would have reduced the flow of hot gases by closing the door part way adding seconds to the egress time.
