# CASE STUDY TO EVALUATE THE EFFECTS OF BUILDING CODE VIOLATIONS ON A FATALITY FIRE

{ Noel Putaansuu, CFI  
Michael M. Fitz, P.E., C.F.E.I., C.F.P.S.  
MDE, Inc. Seattle  
[www.mde.com](http://www.mde.com)

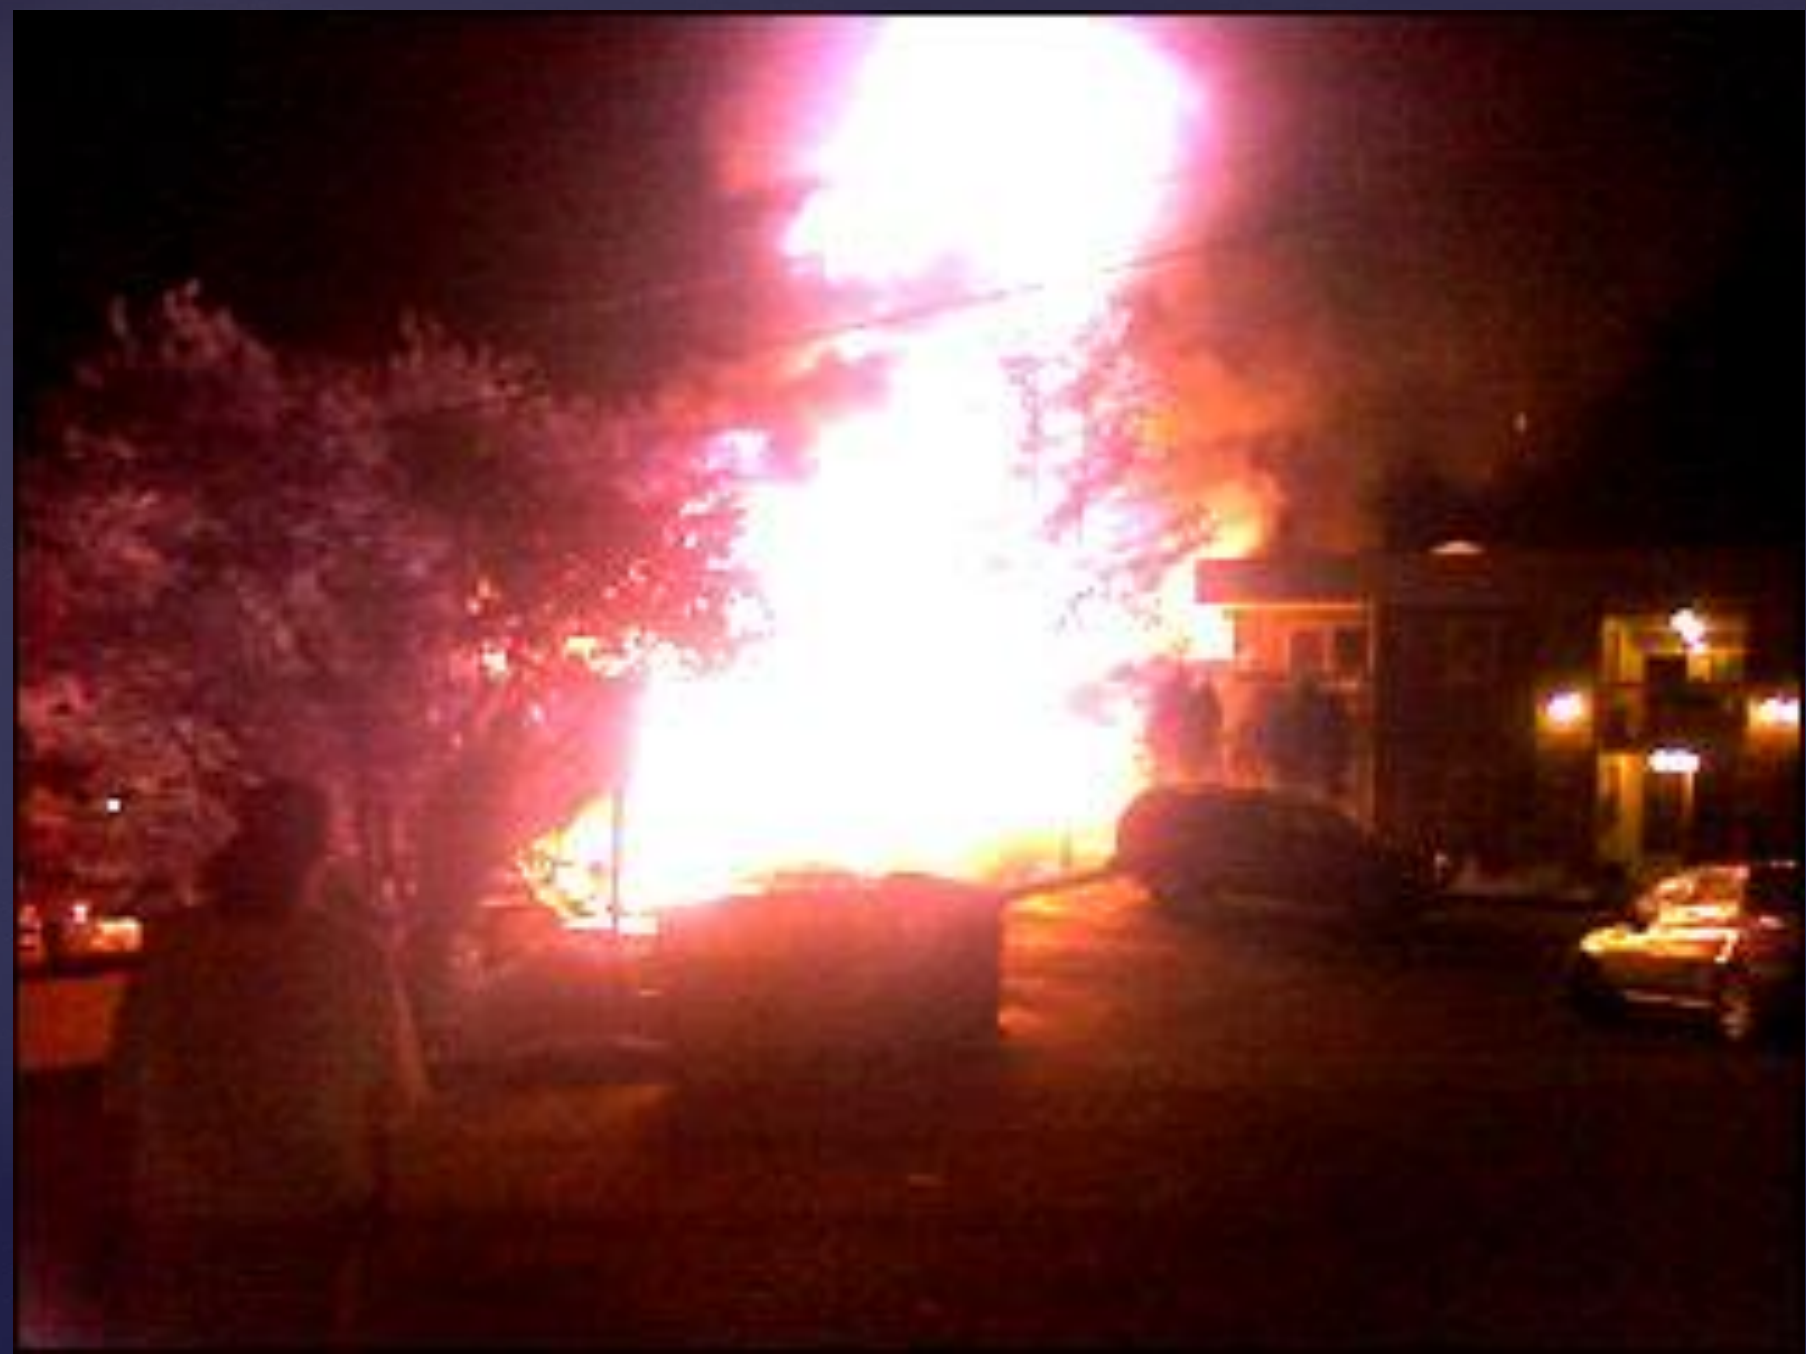
# Events

- ⌘ On a warm summer weekend night near midnight
- ⌘ A fire is noted, 911 called
- ⌘ Bystanders make efforts to alert the occupants
- ⌘ The Fire Department arrives from blocks away and are stunned by the following sight on arrival.....

- & The engines roll in 2 minutes
- & The engines arrive in 5 minutes
- & The building is largely involved and threatening other structures on arrival
- & They know there are trapped people

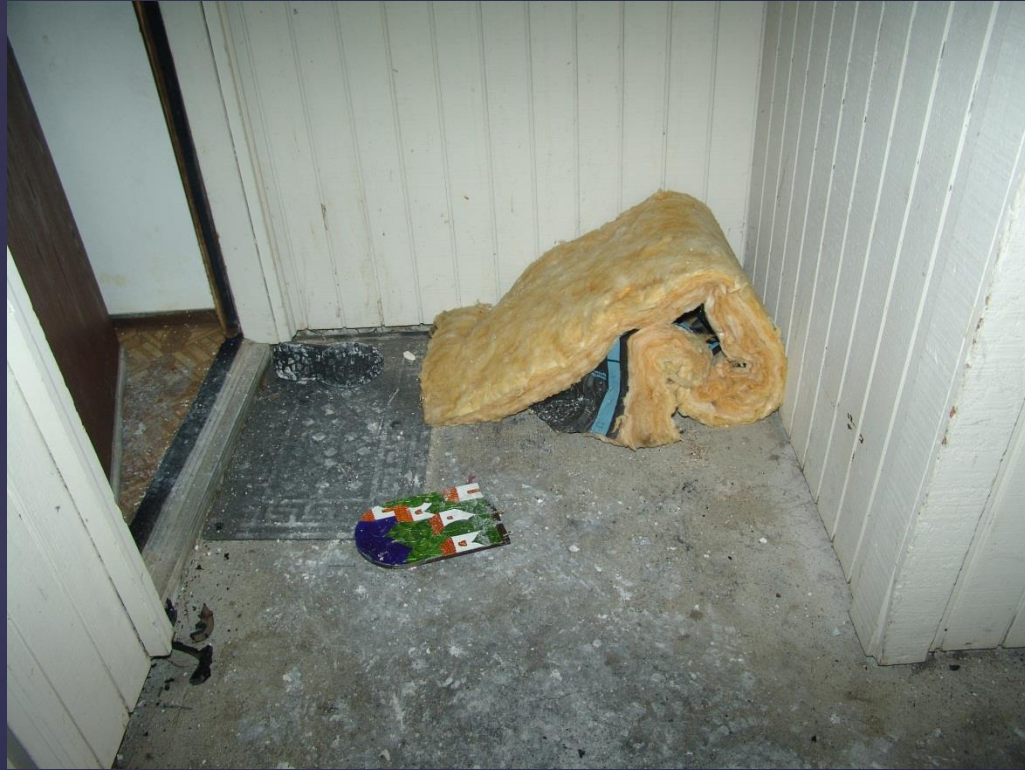
Central Corridor

The initial fire occurs  
hidden from view

- ⌘ Corridor exceeds flame spread limit
- ⌘ Doors not one hour
- ⌘ Doors had no closing hardware
- ⌘ Two exits required, only one for 2<sup>nd</sup> floor units
- ⌘ Corridor slightly longer than 20'

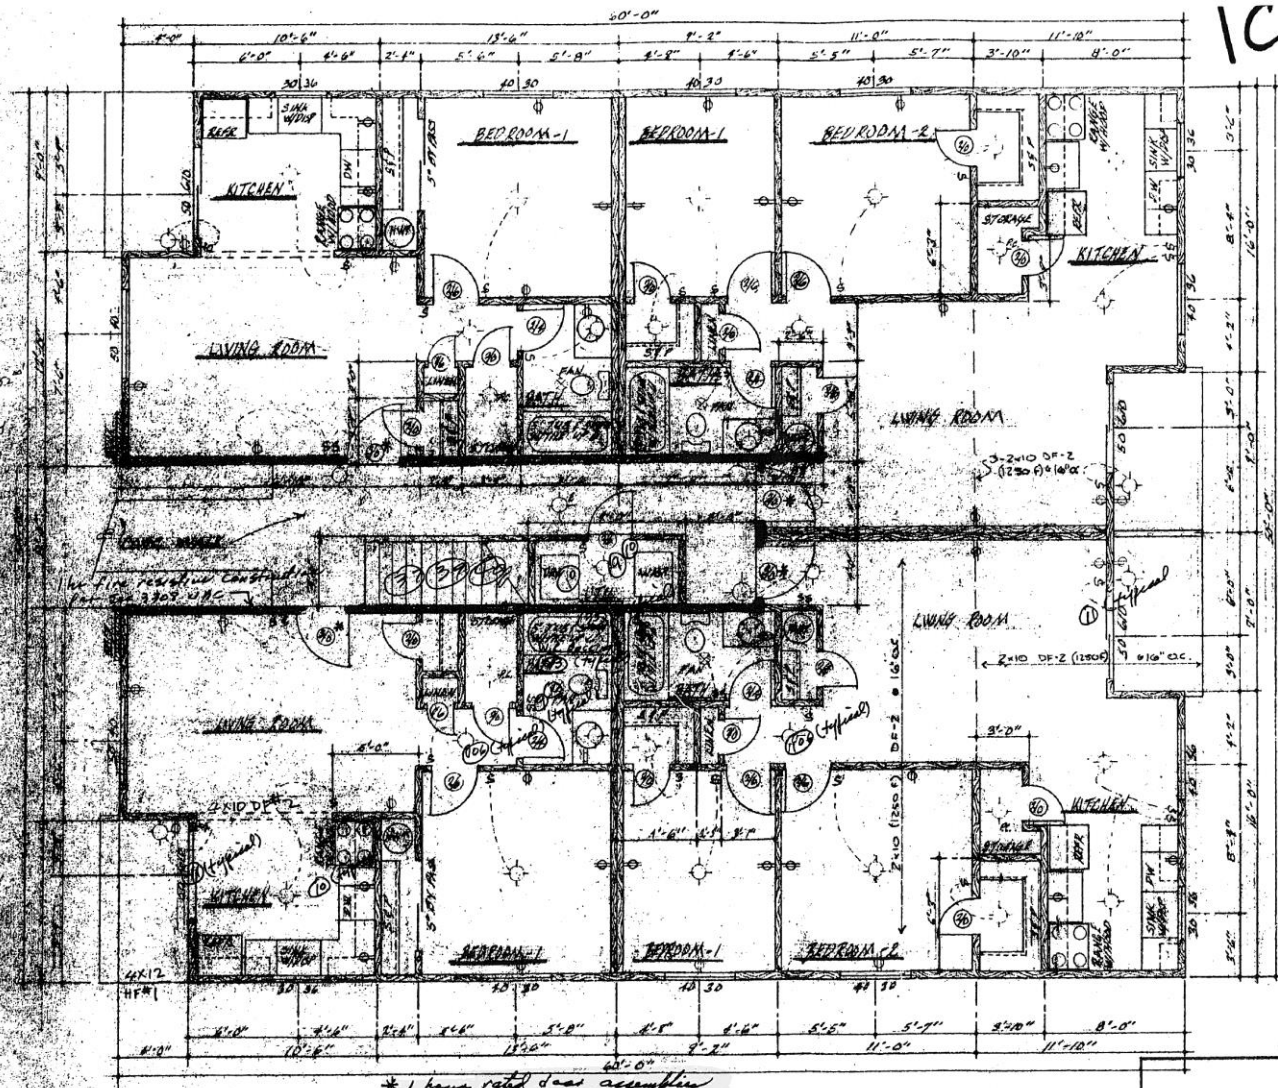
FIRST FLOOR PLAN  
 SCALE: 1/4" = 1'-0"

\* 1 hour rated door assembly  
 Area = 128 (21' - 0" x 6') = 552  
 enclosed - 3  
 Staircase enclosure  
 (2) 12' x 72' (36' x 36')

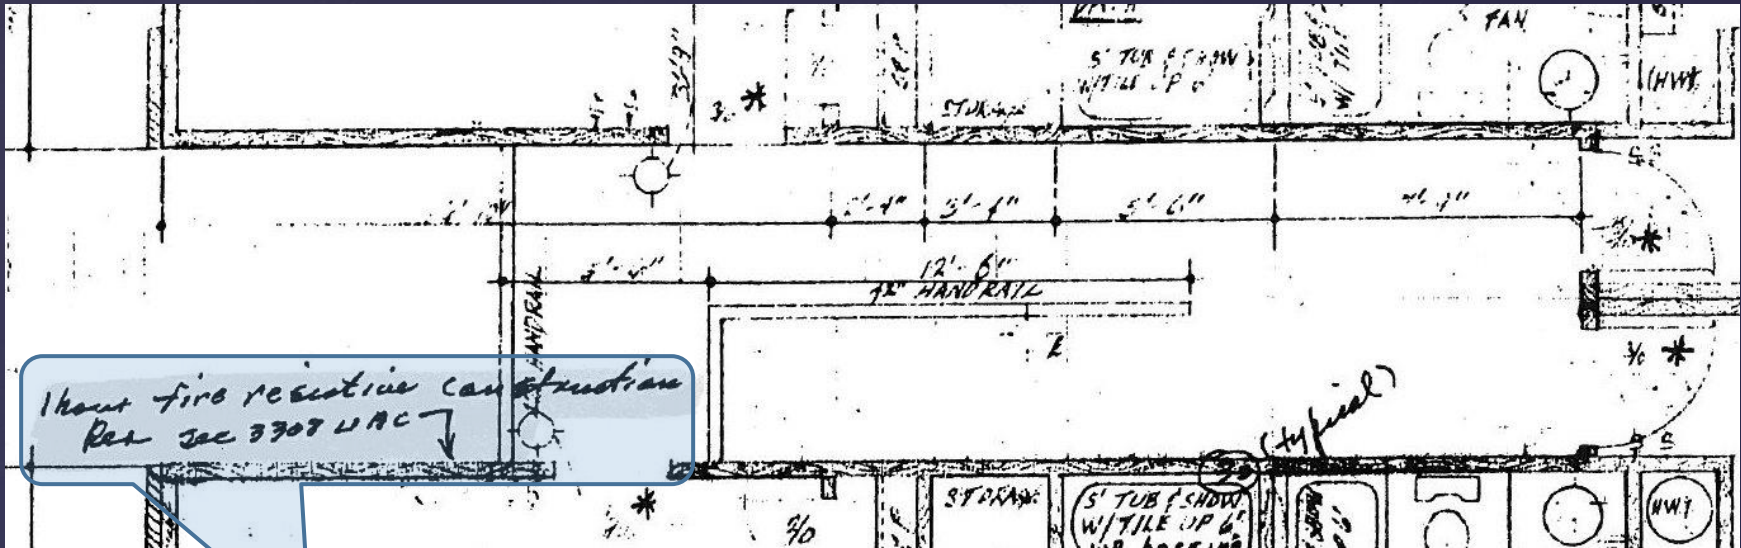
- & 1 hour fire resistive construction
- & Sec 3308 UBC
- & \* at each entry door

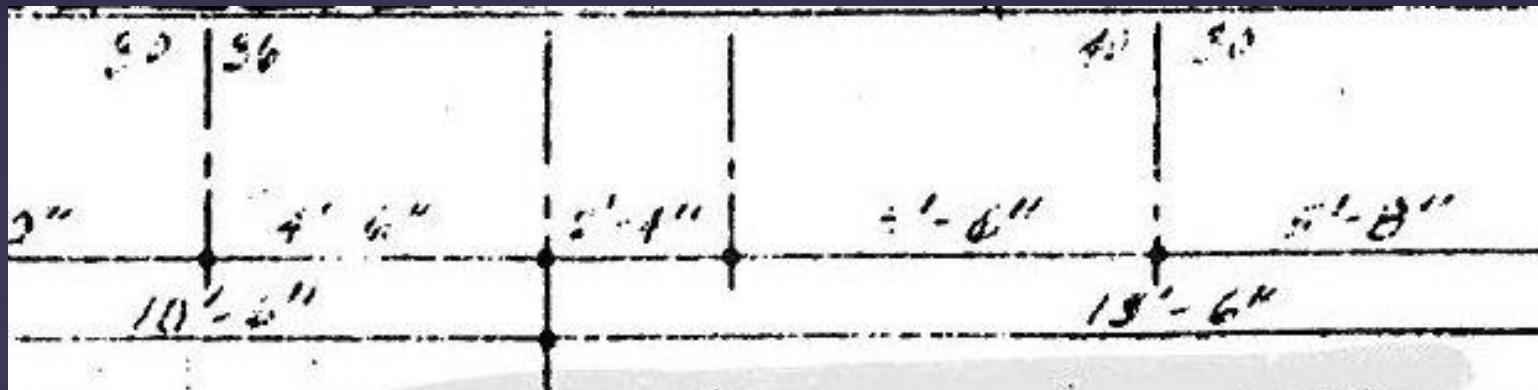
\* 1 hour rated door assemblies

$$\text{area} = (21)(28) - \text{door} = 592$$

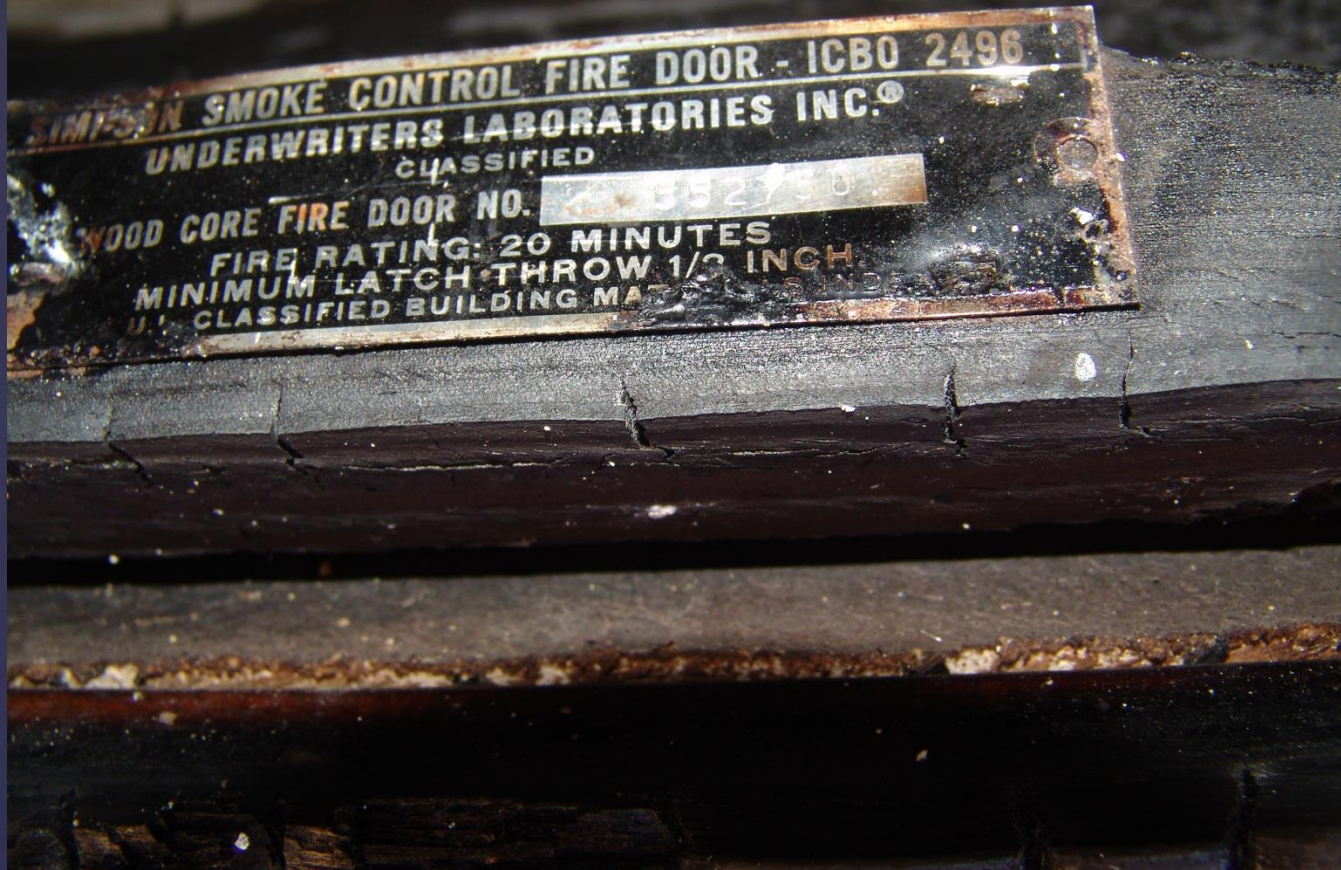
Door Plate

- ‡ 1977 Construction
- ‡ 1973 and 1976 UBC evaluations
- ‡ Sec. 4306 – self closing
- ‡ Sec 3308 – one hour and self closing

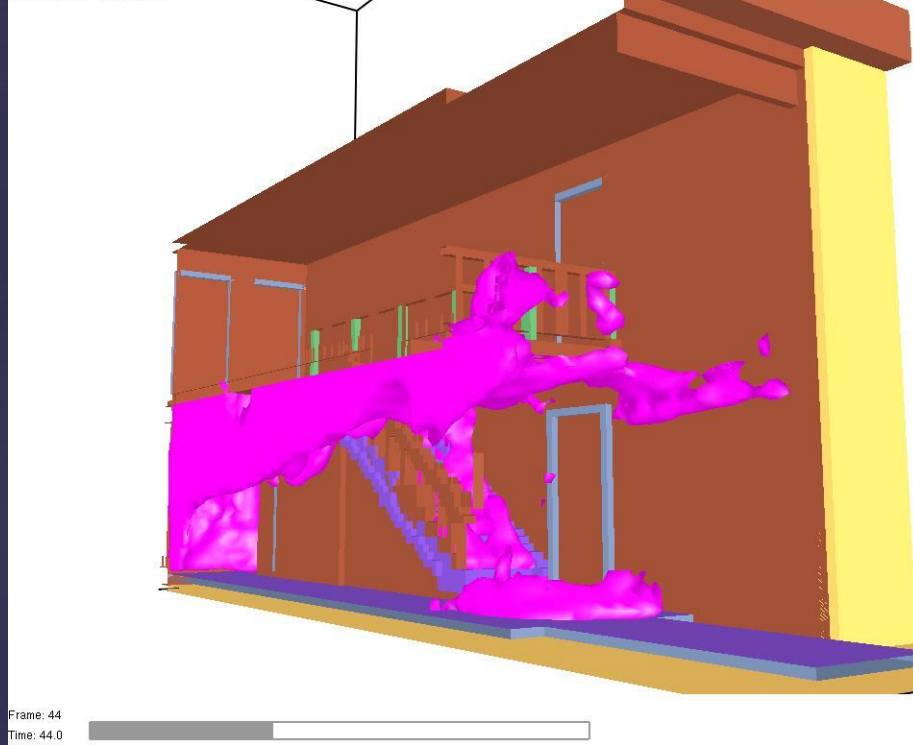
# Untenable Environment

- ⌘ The wood walls and ceiling turned a small fire into an untenable environment
- ⌘ Non-combustible wall, ceiling and floor was tenable with prescribed initial fires as large 500 kW
- ⌘ The pressure on the door was not so great that a door closure would not have functioned at least partially
