USE OF FIRE AND EVACUATION MODELS IN PRACTICE OF FIRE AND RESCUE SERVICE OF THE CZECH REPUBLIC

Václav Vystrčil, Lucie Hasalová

Technical Institute of Fire protection
Prague, Czech Republic
e-mail: vaclav.vystrcil@hzscr.cz

Case Study – Deadly fire in a nursing home

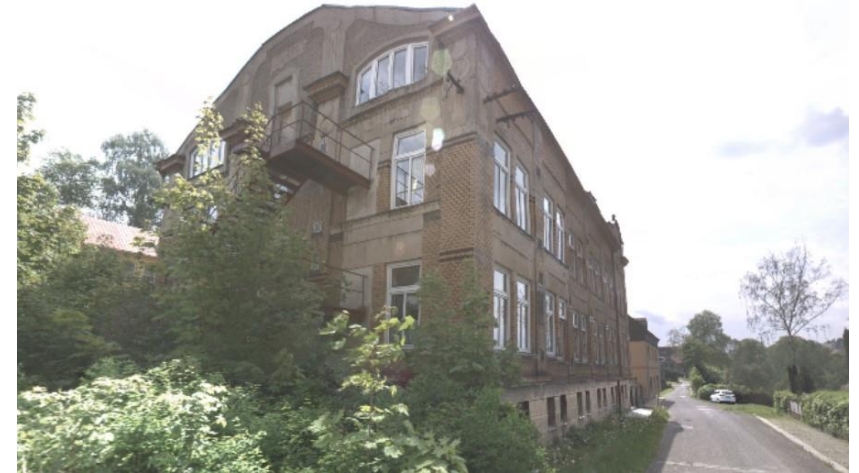
- Building from the year 1985
- Converted from the home for elderly people to home for people with mental illnesses without any special changes...
- 34 clients accommodated in total
- One member of staff during night
- Fire started in early morning between 4 and 5 am.
- It started in the common room - same fire section as five client rooms (17 clients)
- No fire detection
- 8 fatalities and 5 clients seriously injured - one of the most severe fire in last 30 years

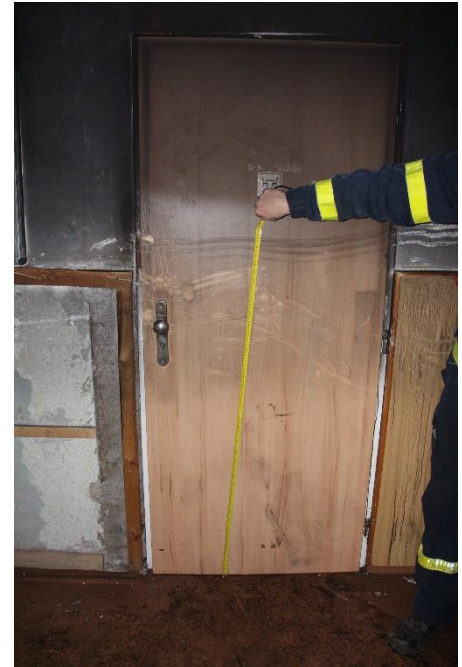
- Authors of the fire model directly on the fire scene few days after the fire
- All the details of the building construction and fire itself could have been studied from the point of view of the model input parameters and traces.
- Best traces, which were then used in calibrating the model was height of the smoke layer determined by soot deposits on the walls and temperature profile, which was determined by various items...
