## **CASE STUDY TO EVALUATE EFFECTS OF BUILDING CODE VIOLATIONS ON THE OUTCOME OF A FATALITY FIRE**

Noel Putaansuu, CFI, Michael M. Fitz, P.E., C.F.E.I., C.F.P.S.

MDE Inc.  
700 S Industrial Way  
Seattle, WA 98108  
e-mail: NoelP@mde.com

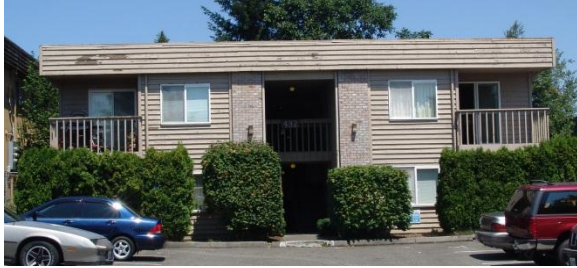
Constructed in 1977-78, this apartment house layout had four apartments on the 1<sup>st</sup> floor and four apartments on the 2<sup>nd</sup> floor. All units had main entries into a central covered corridor. Each unit had a sliding glass door to porches on the 1<sup>st</sup> floor and balconies on the 2<sup>nd</sup> floor. There were two one-bedroom and two two-bedroom units on each floor (Figure 1).

Figure 1: Exemplar apartment structure front.

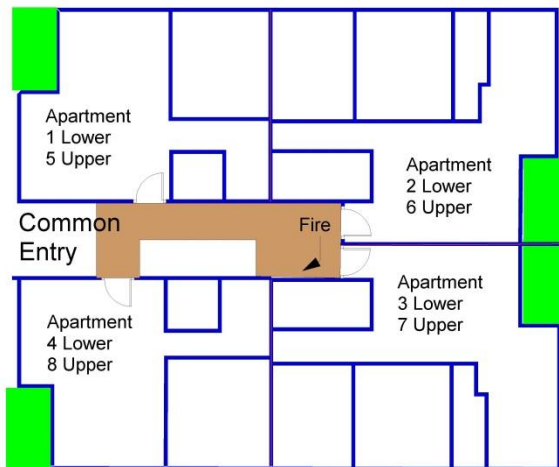
The covered central entry served as the /exit pathway for the main entry of each unit on both floors. A stairway in the central corridor provided access to the second floor with a washer, dryer and supporting water heater located in a closet under the stairs (Figures 2 and 3). This laundry area under the stairs was covered with gypsum wall board.

Figure 2: Central Corridor in brown, walls in blue and balconies in green

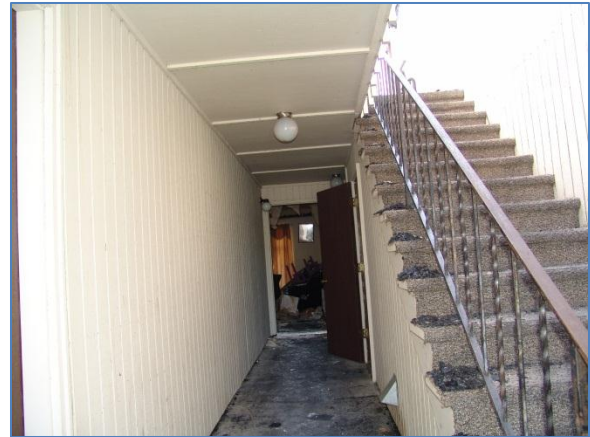
Figure 3: Exemplar structure central corridor and stair. Laundry door under stair.
