# CASE STUDY TO EVALUATE THE EFFECTS OF BUILDING CODE VIOLATIONS ON A FATALITY FIRE

{ Noel Putaansuu, CFI  
Michael M. Fitz, P.E., C.F.E.I., C.F.P.S.  
MDE, Inc. Seattle  
[www.mde.com](http://www.mde.com)

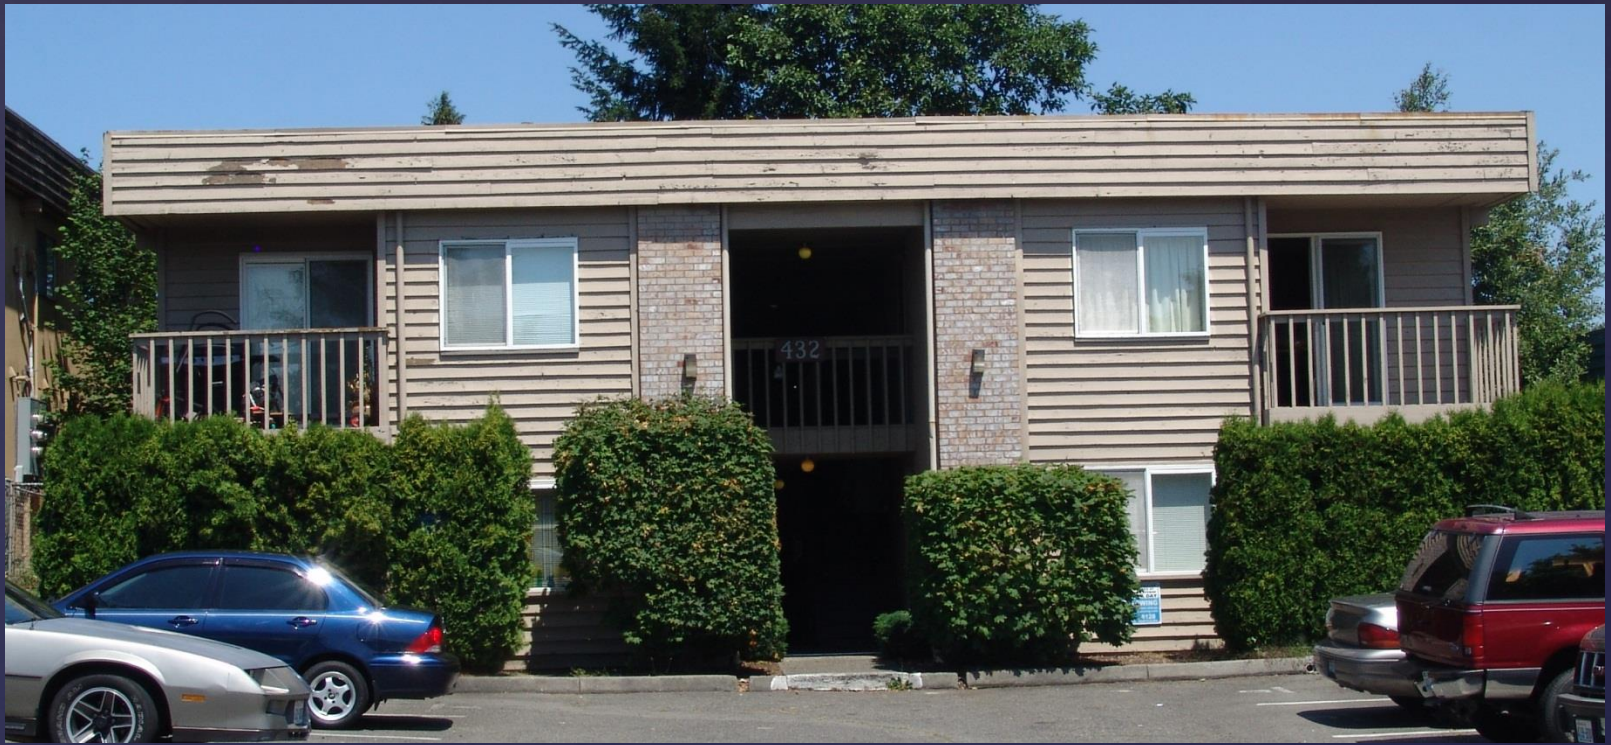
## The Tragedy

- & The engines roll in 2 minutes
- & The engines arrive in 5 minutes
- & The building is largely involved and threatening other structures on arrival
- & They know there are trapped people

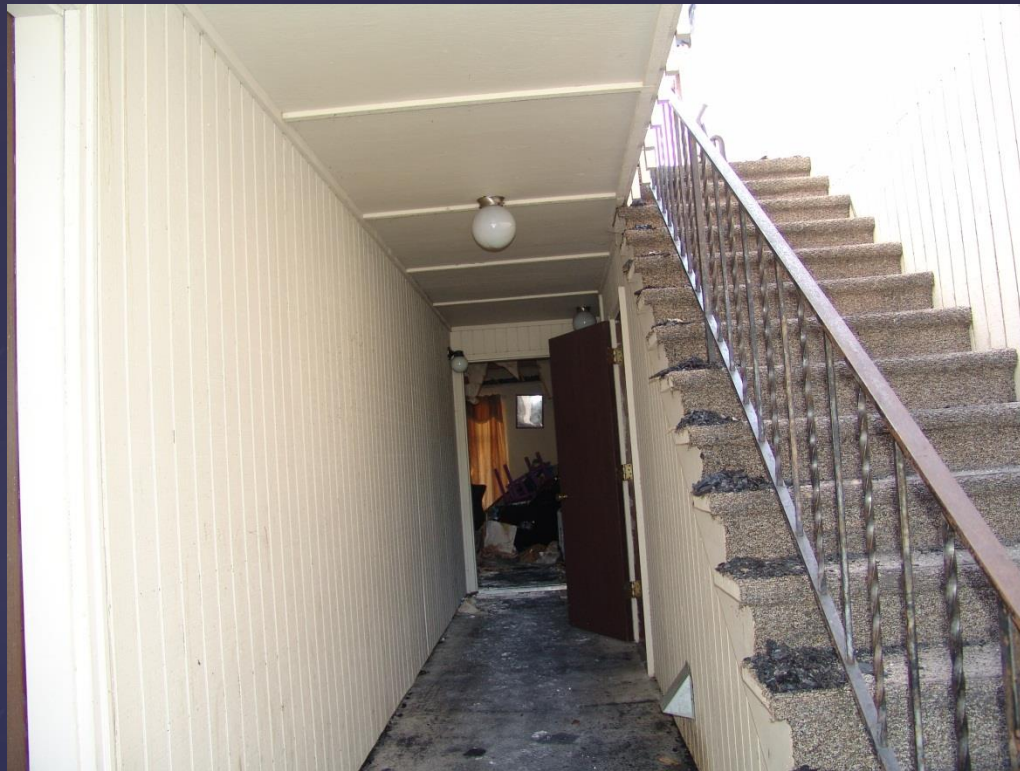
# Common Apartment Layout

Central Corridor

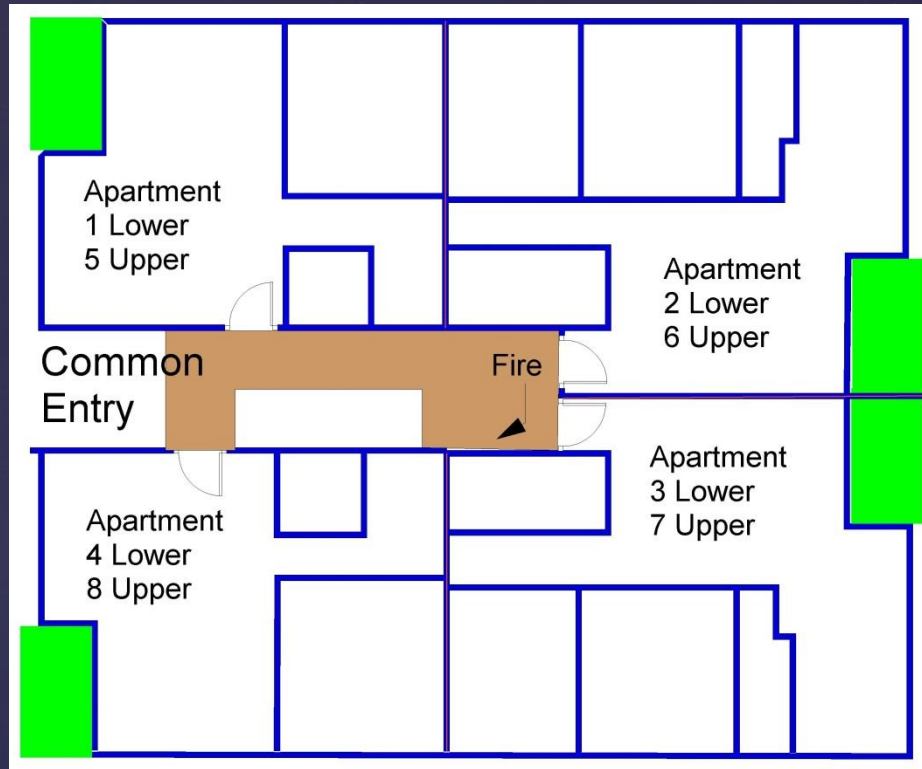
# Building Construction

- ⌘ 1977 Construction
- ⌘ 5 structures all plans approved
- ⌘ Main entry to apartments in central corridor
- ⌘ T1-11 siding exterior
  - ⌘ Building exterior
  - ⌘ Central corridor
- ⌘ Plywood ceiling
- ⌘ Carpet in central corridor
